**Flood Control Project Maintenance
Levee Inspections**

Fall 2016 Levee Maintenance Deficiency Summary Report

San Joaquin River Basin

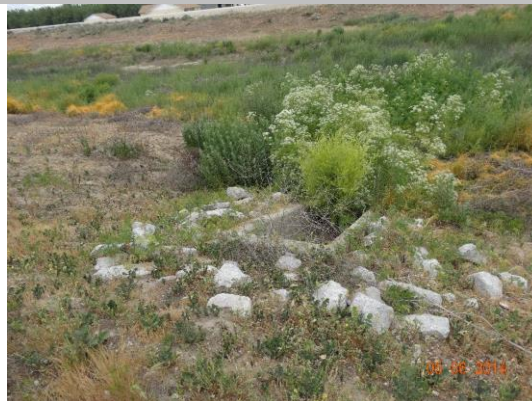
Photo 2 of 2 : UCIP_FA_2016_35806_64599.jpg

LM Start	8.53	Rating **	M	Issue No.	50
LM End	8.53	Issue Type +	En	Location *	LS
Category	Supplemental			GPS Latitude/Longitude	
				Start	End
Item	DWR UCIP Field Study			36.971462 °	36.971462 °
				-120.220276 °	-120.220276 °
DWR ID					
Comment Code					
Inspector Comment					
FS_ID:35806 DS_ID:21534 EP_NO: N/A Repair Type: Non-Urgent Crossing Status: Found UCIP Comments: Need to contact owner. Rip rap has been added around concrete headwall on waterward side--need to determine details for rip rap around structure. FIELD_STRUCT_DESC: 30-inch CM pipe through levee, 11.0 feet below crown. Headwalls and wingwalls on both ends. Flap gate on waterward end. FS Date: 5/6/2014

Rip rap around concrete headwall located on waterward side.

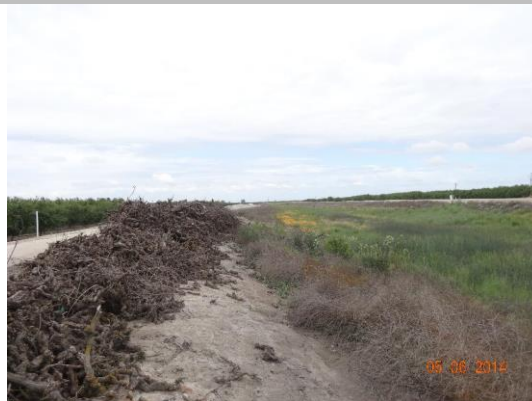
Photo 1 of 2 : UCIP_FA_2016_49981_64605.jpg

Comment Code					
Inspector Comment					
FS_ID:49981					
DS_ID:21530					
EP_NO: N/A					
Repair Type: Urgent					
Crossing Status: Found					
UCIP Comments: 7/14/2016 Surface erosion still present on LS shoulder. Unable to determine if surface erosion is due to internal pipe failure. Unable to locate concrete headwall on WS toe. Need to coordinate with owner to address erosion or potential pipe failure. Also recommend removing dense vegetation on WS. (DWR UCIP - omagana)5/06/2014 Need to contact owner. Surface erosion on landward slope unable to determine if pipe failed or if rodent activity burrow hole has caused collapse on slope. Need to determine cause for erosion. (DWR UCIP - omagana)					
FIELD_STRUCT_DESC: 30-inch corrugated metal drainage pipe through levee, 10.2 feet below crown. Headwalls and wingwalls are located on both waterside (WS) and landside (LS) ends. Flap gate is located on the WS end.

View of WS.

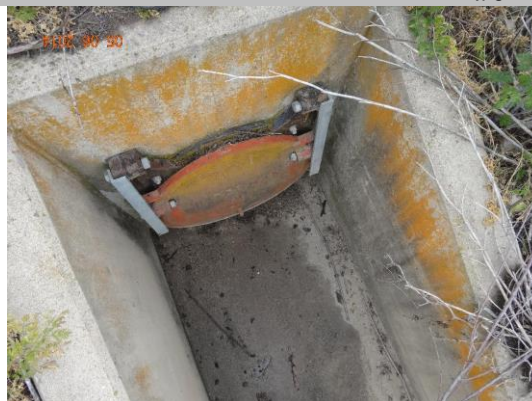
Photo 2 of 2 : UCIP_FA_2016_49981_64604.jpg

Comment Code					
Inspector Comment					
FS_ID:49981 DS_ID:21530 EP_NO: N/A Repair Type: Urgent Crossing Status: Found UCIP Comments: 7/14/2016 Surface erosion still present on LS shoulder. Unable to determine if surface erosion is due to internal pipe failure. Unable to locate concrete headwall on WS toe. Need to coordinate with owner to address erosion or potential pipe failure. Also recommend removing dense vegetation on WS. (DWR UCIP - omagana)5/06/2014 Need to contact owner. Surface erosion on landward slope unable to determine if pipe failed or if rodent activity burrow hole has caused collapse on slope. Need to determine cause for erosion. (DWR UCIP - omagana) FIELD_STRUCT_DESC: 30-inch corrugated metal drainage pipe through levee, 10.2 feet below crown. Headwalls and wingwalls are located on both waterside (WS) and landside (LS) ends. Flap gate is located on the WS end. FS Date: 7/14/2016

Flap gate visible on WS.
